Project name:
Hillcrest

Contract number:
1138

Inspection report

Road: 104-106 Holland Park Avenue	Division:	start MH: MH 1
Place: London, W11 4UA	District:	end MH: Sewer
Location: Basement Area	Tape No.: DVD	Total length: 7.5 m

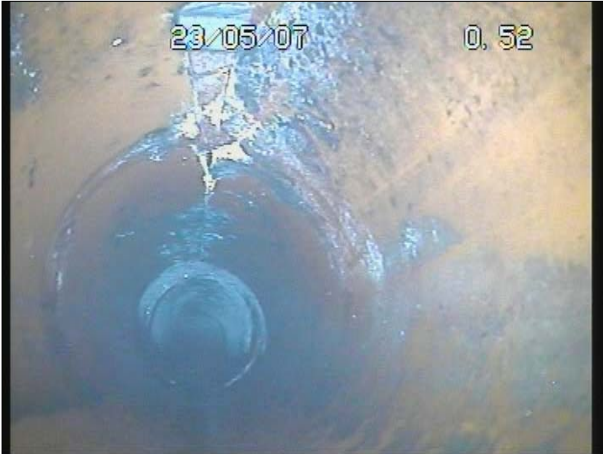
Photo: 3a, Tape No.: DVD, 00:00:00
0.5m, Longitudinal Crack, at 12 o'clock, Start

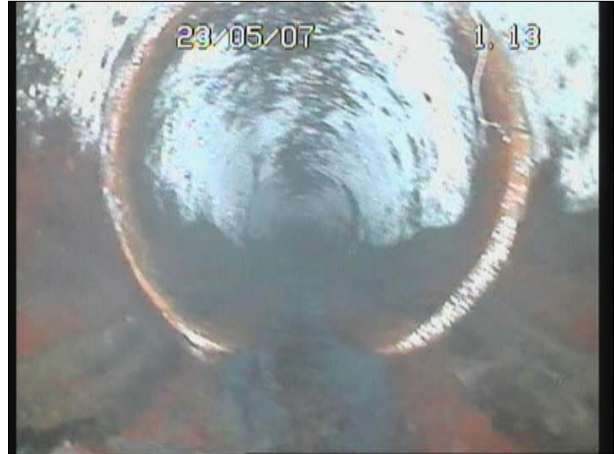
Photo: 4a, Tape No.: DVD, 00:00:00
1.2m, Joint displaced. Small

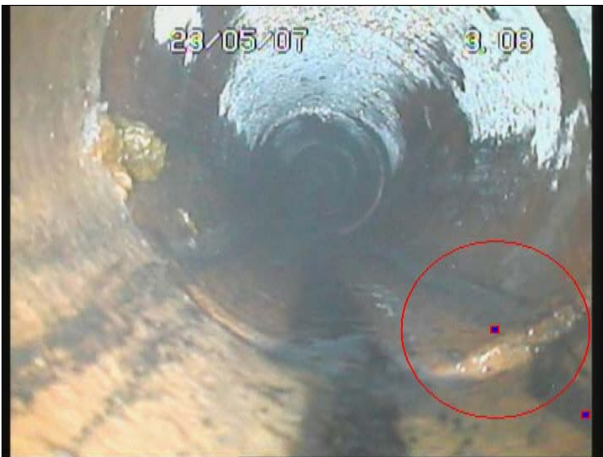
Photo: 1_6a, Tape No.: DVD, 00:00:00
3.1m, Joint displaced. Medium

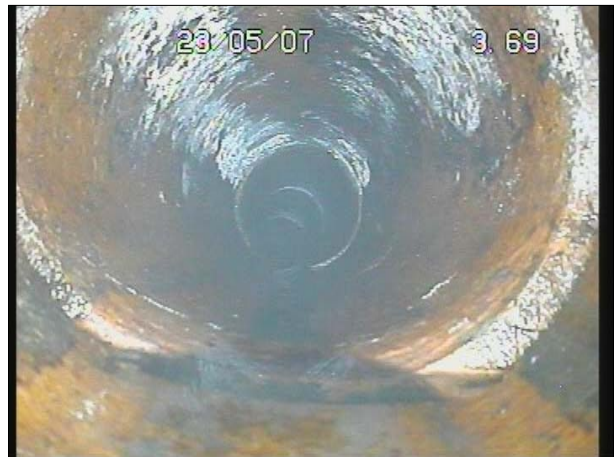
Photo: 8a, Tape No.: DVD, 00:00:00
3.7m, Joint displaced. Medium

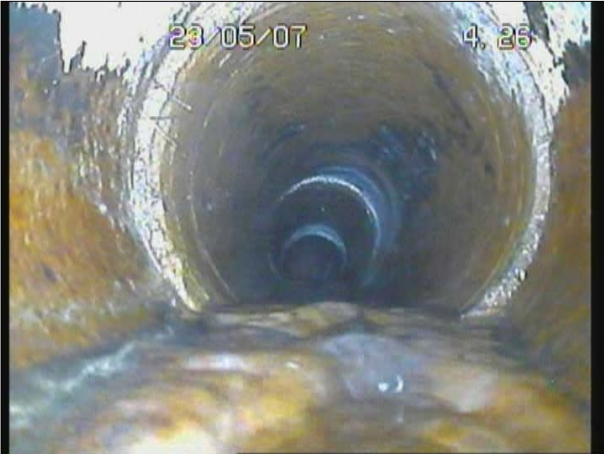
Photo: 9a, Tape No.: DVD, 00:00:00
 4.3m, Joint displaced. Medium

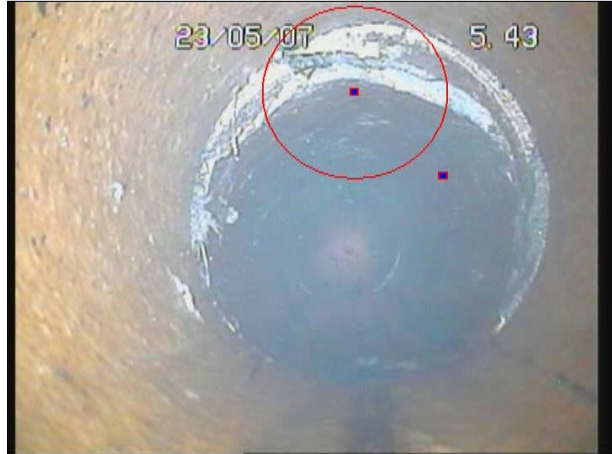
Photo: 1_10a, Tape No.: DVD, 00:00:00
 5.5m, Open joint large

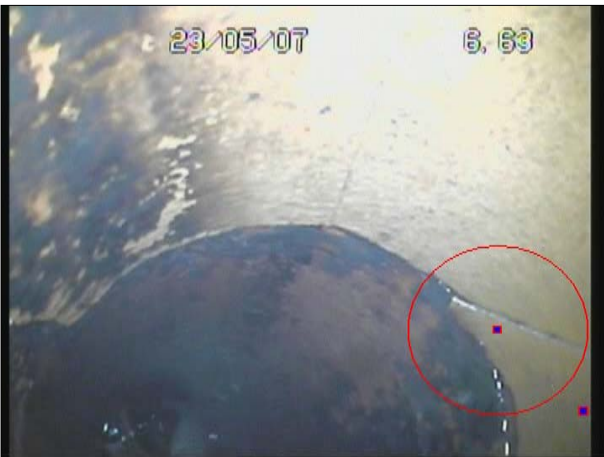
Photo: 1_13a, Tape No.: DVD, 00:00:00
 6.6m, Longitudinal Crack, at 02 o'clock

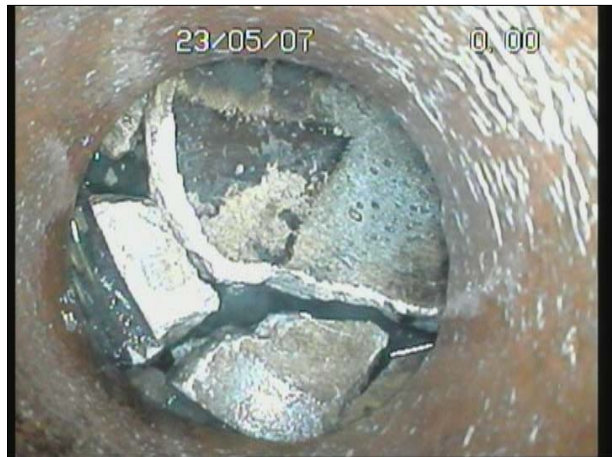
Photo: 2a, Tape No.: DVD, 00:00:00
 7.1m, Broken Pipe - Base bend on tumbler before main sewer has broken

Comment: **Excavation required to repair**
 Location details: **broken section of pipe, and liner needed aswell**
