## Project-information

Project name:  
**Nexus**

# Inspection report

Date: <b>14/06/2007</b>	Job N°: <b>1172</b>	Weather: <b>Dry</b>	Operator: <b>Graham Dal</b>	section number: <b>1</b>	PLR: <b>MH1-Run1 X</b>
Present:	Vehicle: <b>CE56 UUJ</b>	Camera:	Preset:	Cleaned:	Grade:

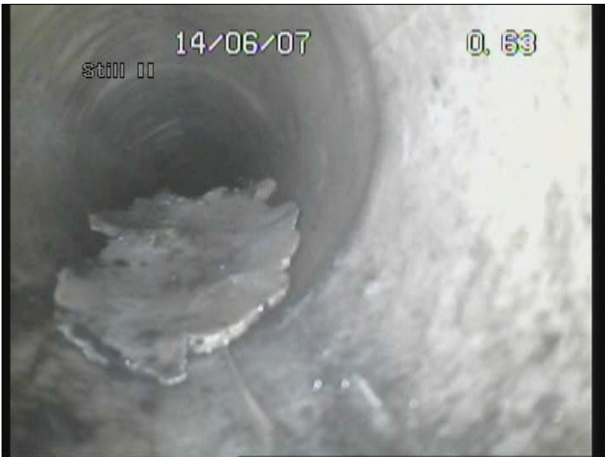
Photo: 2a, Tape No.: DVD, 00:00:00  
 0.2m, Debris, Start

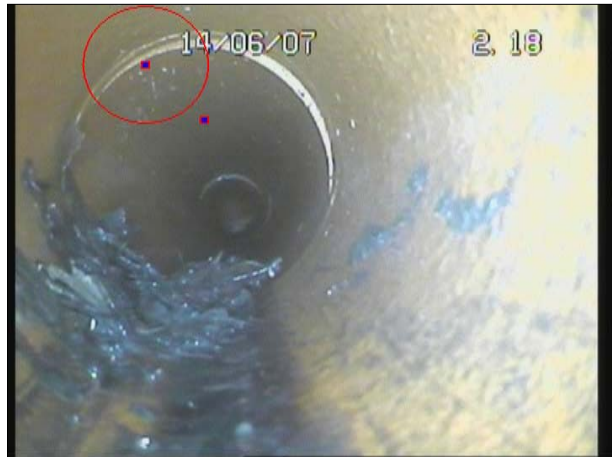
Photo: 1\_4a, Tape No.: DVD, 00:00:00  
 2.18m, Circumferential Crack, from 09 to 03 o'clock

Comment: **Pipe requires cleaning and lining**

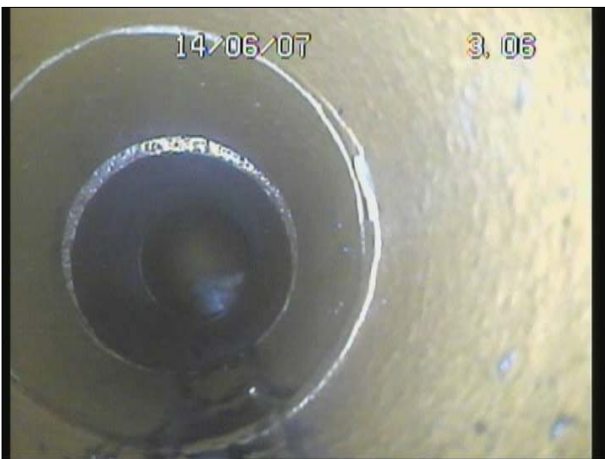
Photo: 12a, Tape No.: DVD, 00:00:00  
 3.06m, Circumferential Crack, from 12 to 12 o'clock

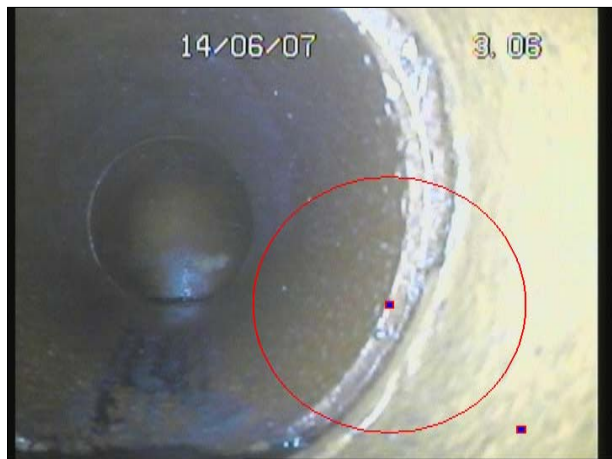
Photo: 1\_6a, Tape No.: DVD, 00:00:00  
 3.1m, Joint displaced. Medium

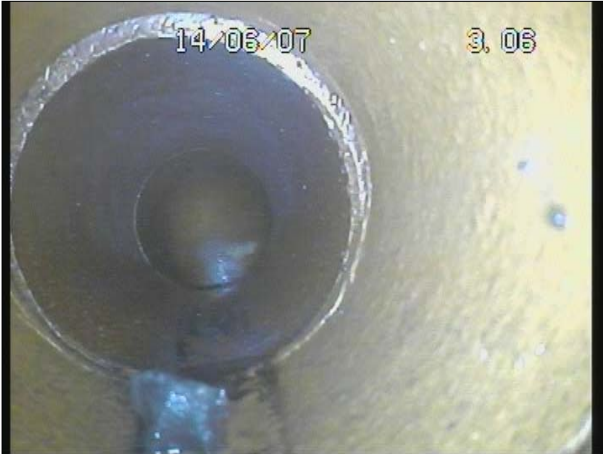
Photo: 6b, Tape No.: DVD, 00:00:00  
3.1m, Joint displaced. Medium
