## Project-information

Project name:  
**Nexus**

# Inspection report

Date: <b>14/06/2007</b>	Job N°: <b>1172</b>	Weather: <b>Dry</b>	Operator: <b>Graham Dal</b>	section number: <b>1</b>	PLR: <b>MH1-Run1 X</b>
Present:	Vehicle: <b>CE56 UUJ</b>	Camera:	Preset:	Cleaned:	Grade:

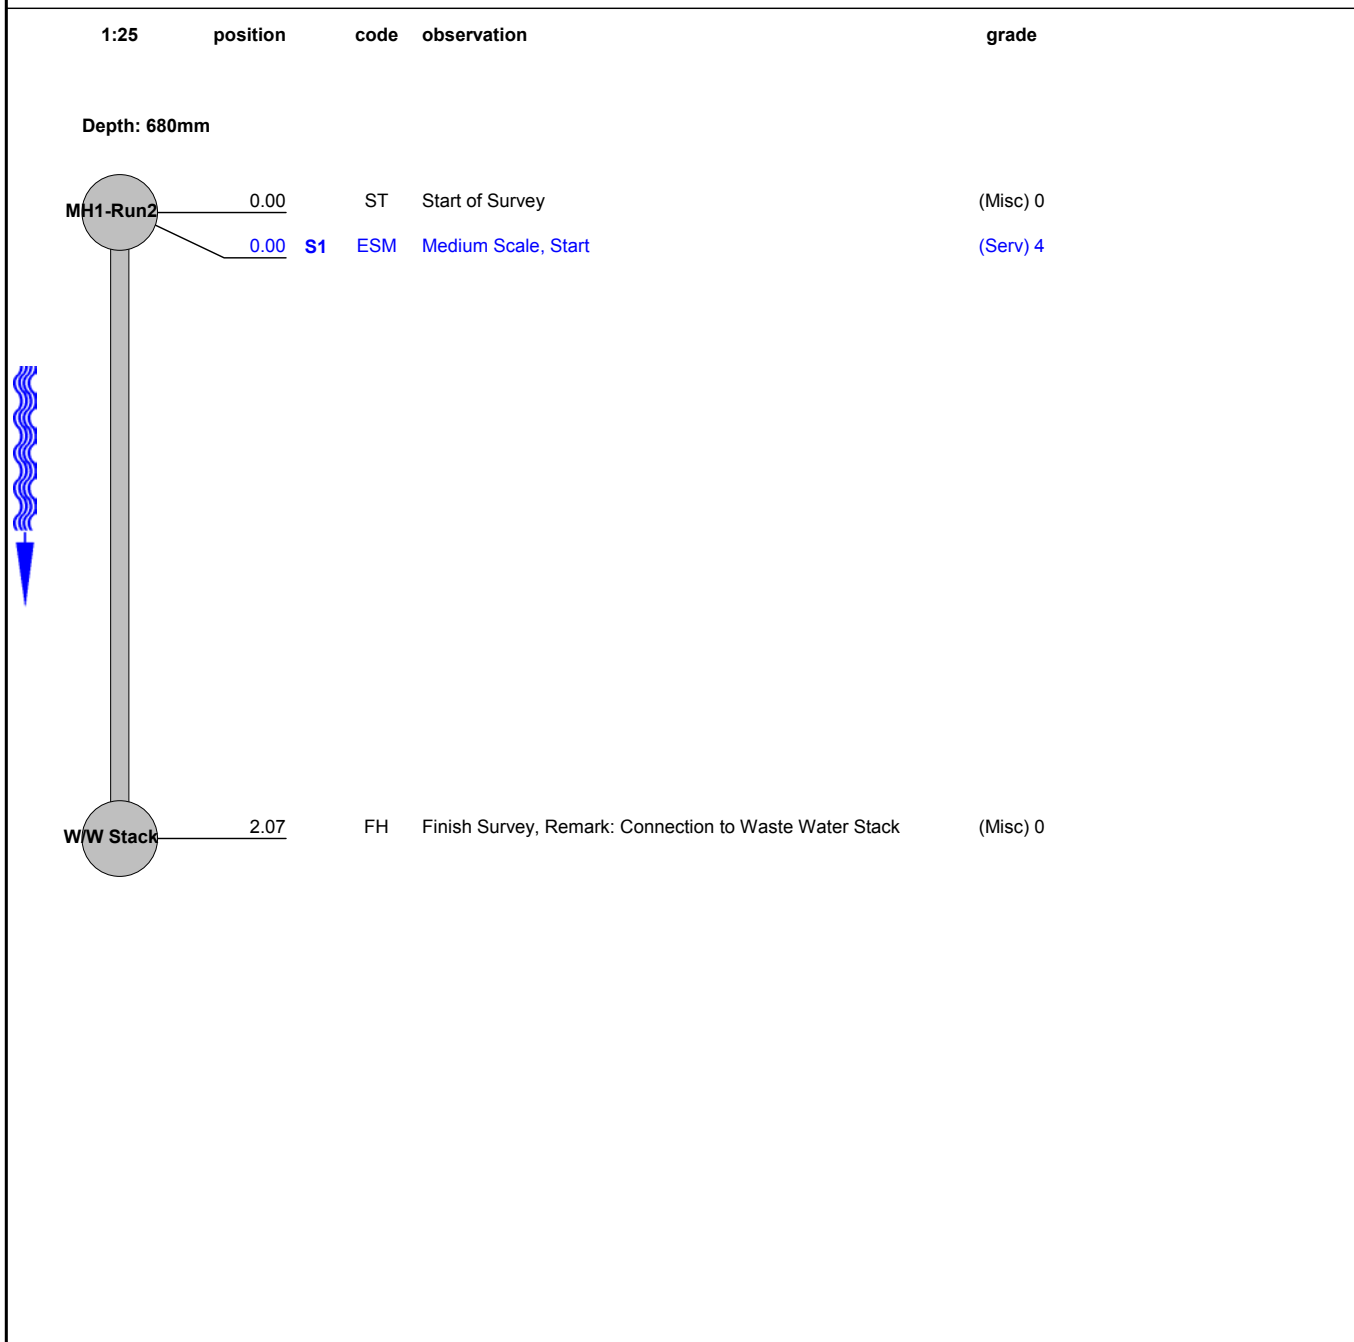
Purpose: <b>Find cause of bad smells</b>	Size/Shape: <b>Circular 100</b>
Use: <b>Waste Water</b>	Material: <b>Vitrified Clay</b> Pipe length:
Catchment:	Lining: <b>No</b>
	Category:

Comment: **Pipe requires cleaning/descaling**

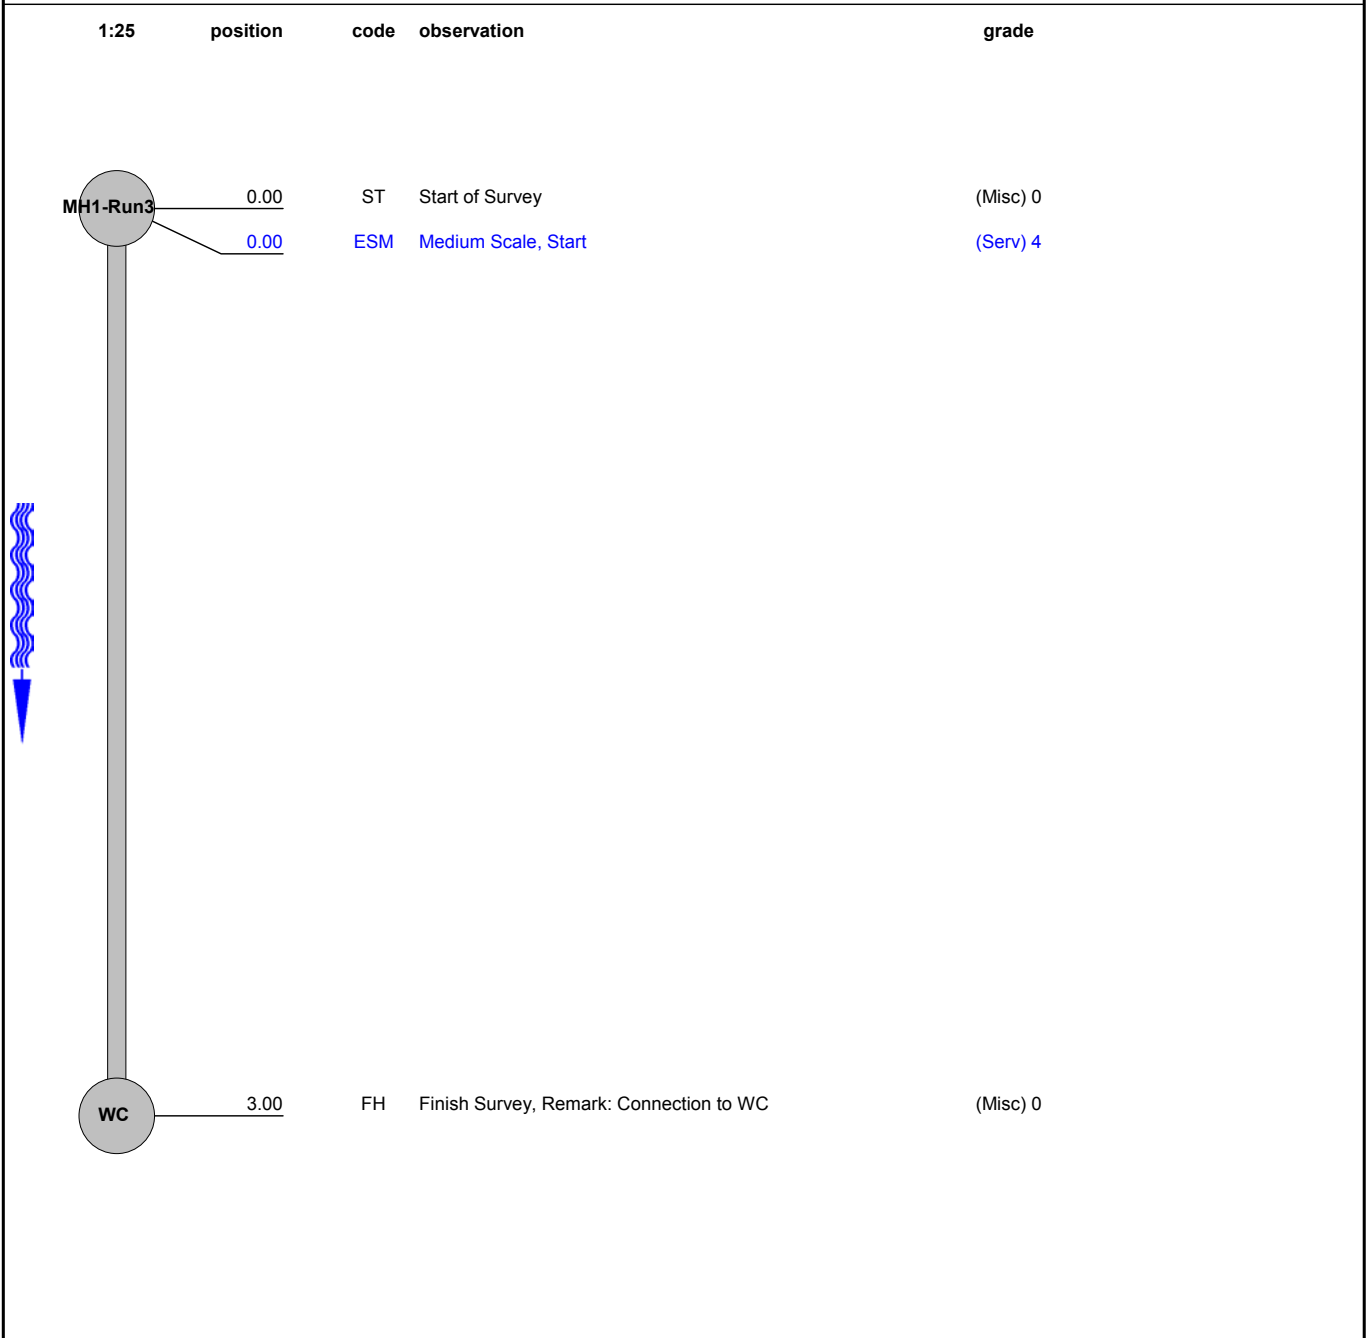
Purpose: <b>Find cause of bad smells</b>	Size/Shape: <b>Circular 100</b>
Use: <b>Soil</b>	Material: <b>Vitrified Clay</b> Pipe length:
Catchment:	Lining: <b>No</b>
	Category:

Comment: **Pipe requires cleaning/descaling**
